Hang Gliding and Paragliding Association of Canada  
Association Canadienne de Vol Libre

## FLIGHT SAFETY INVESTIGATION REPORT

PARAGLIDING ACCIDENT

MONT YAMASKA, QC

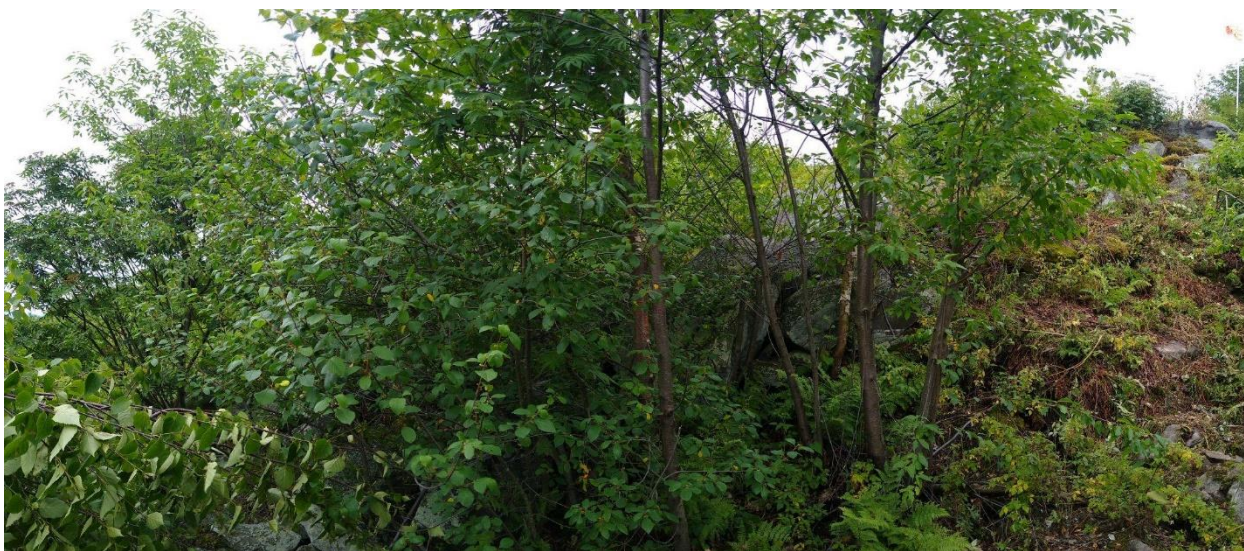
The terrain below PVLMY's North takeoff site is relatively clear and features groups of trees and bushes, especially on the right (east side), and several groups of rocks. The impact took place on one of those groups of rocks on the left side (west side). The Student was found face down, unconscious, without his helmet (it seems that one of the helmet straps broke under impact), his harness on top of him, the deflated Wing a bit behind on bushes (toward the North). See pictures at appendix 4.

Windsock (top right) and rocks at impact point (bottom left) (panoramic format)

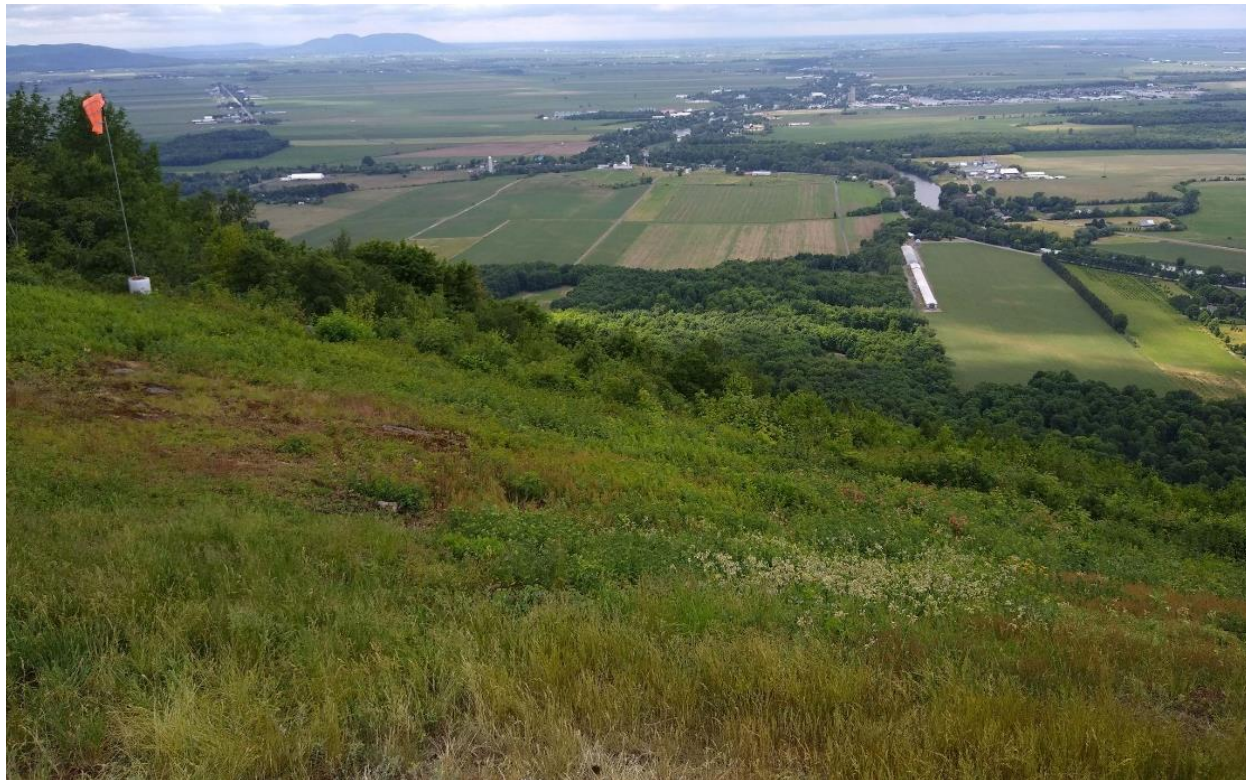
Terrain just below the flat part of the takeoff site (left side, NW)

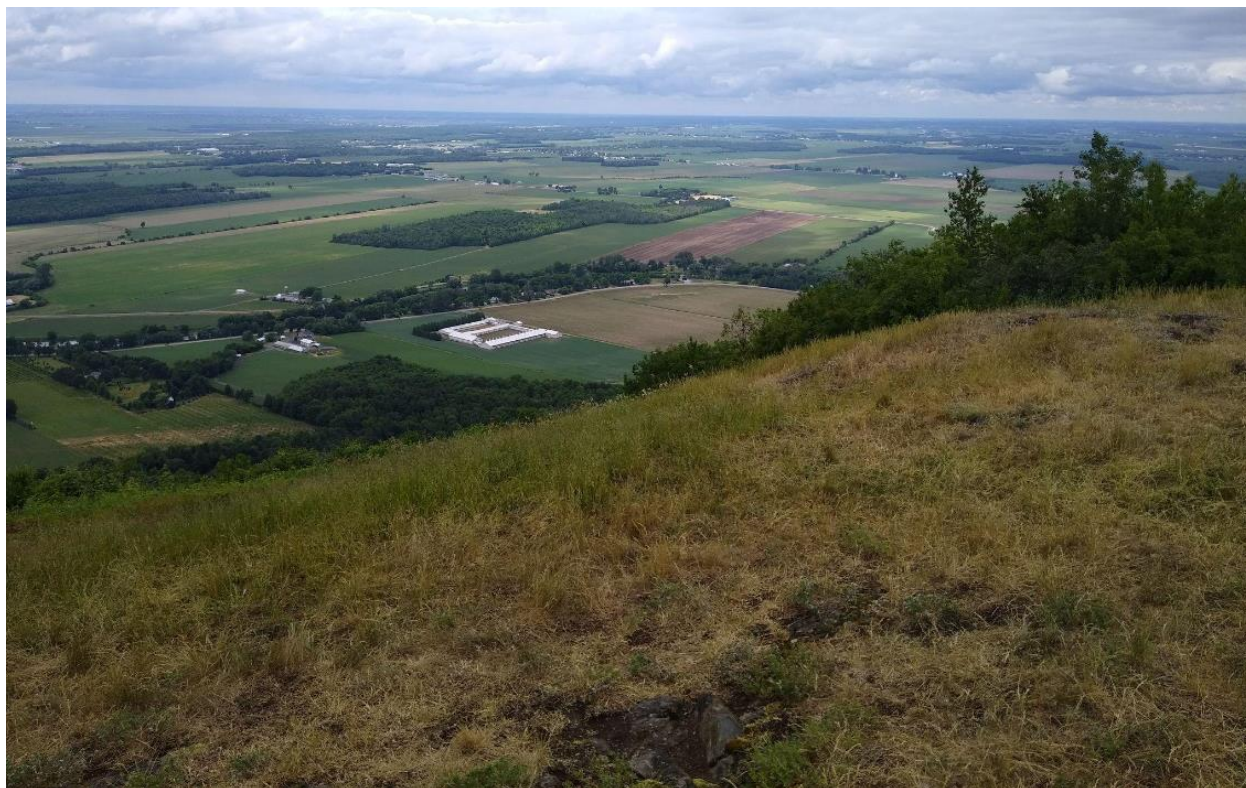
Terrain just below the flat part of the takeoff site (right side, North-East)

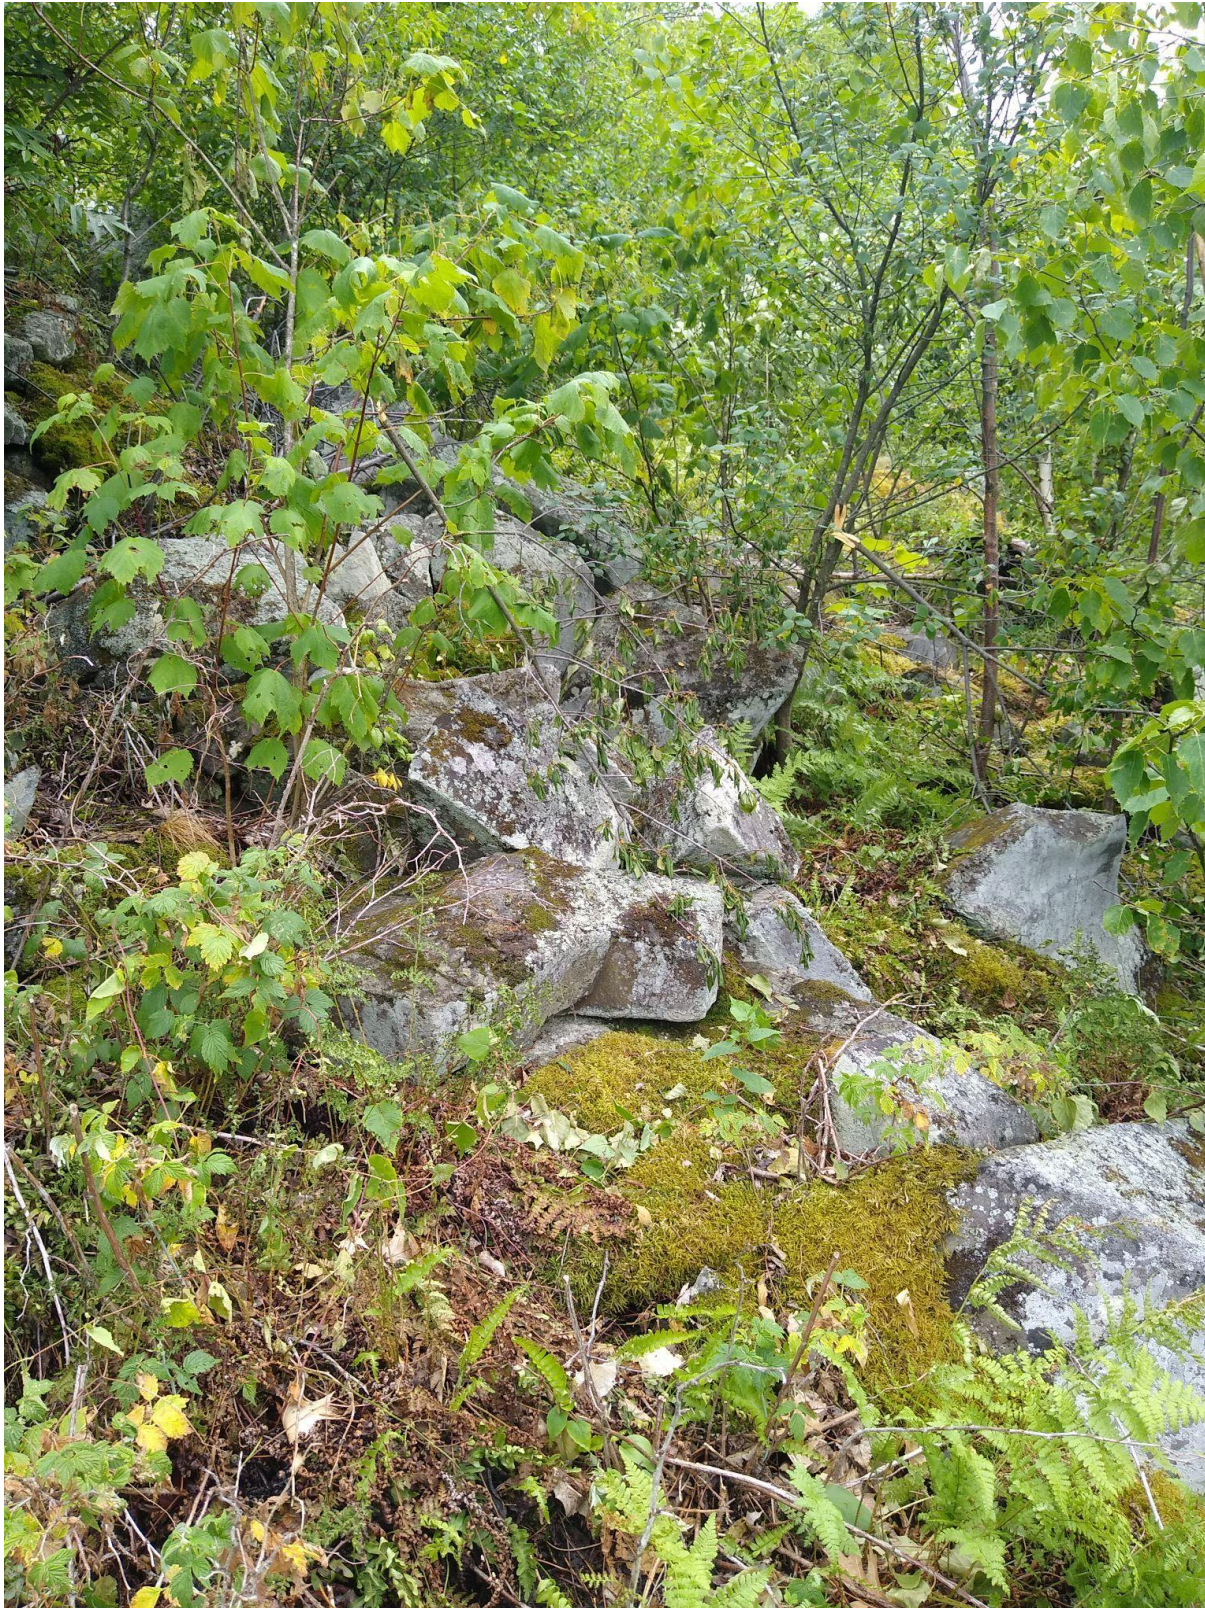
Rocks at impact point

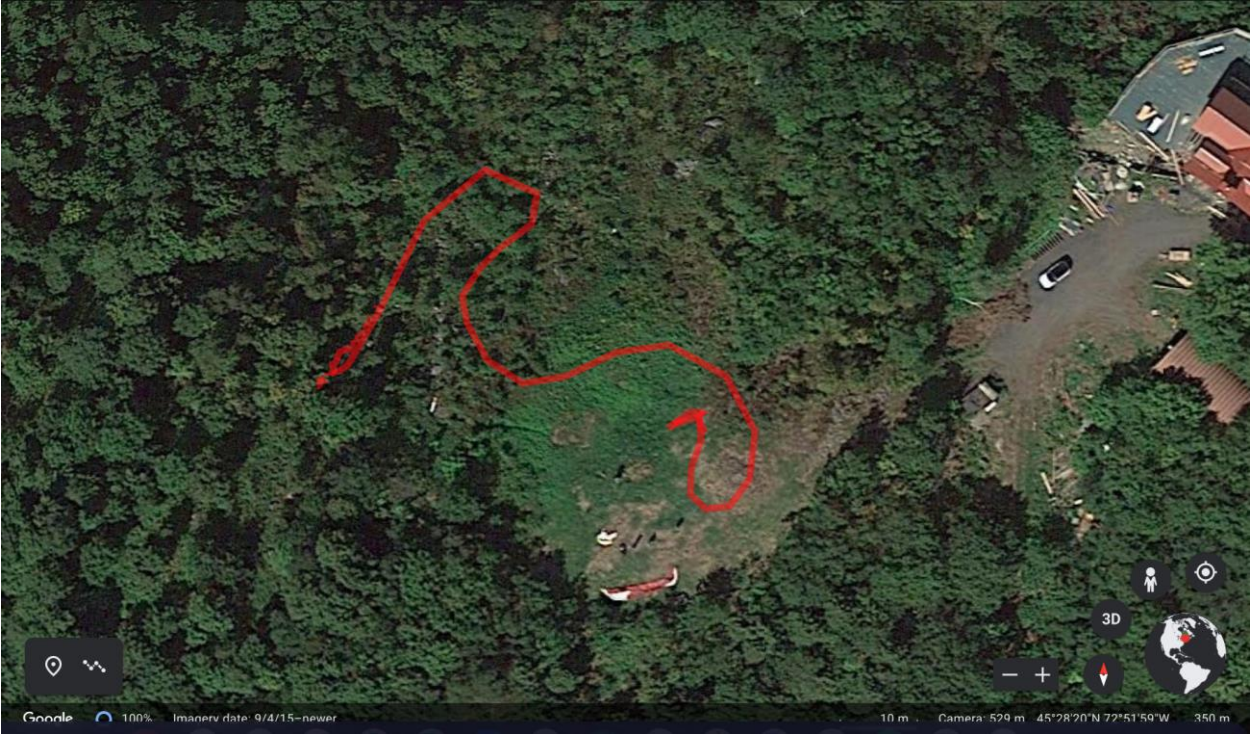
The Student’s flight path is known because flight data from his variometer/GPS was retrieved. The data (frequency: 1 sample per second) includes timestamp, latitude and longitude, and altitude (which allows applications to roughly calculate ground speed and vertical speed). The trajectory given by the flight data corresponds closely with the eyewitness testimonies which, moreover, differ little from each other. Flight data indicates that the flight started around 12:18 p.m. and lasted for approximately thirty-four (34) seconds. This data allowed the investigation to reconstruct the flight in the form of animation as well as to overlay the track on satellite imagery of the site; see appendix 6.

Flight path seen from above (Google Earth)

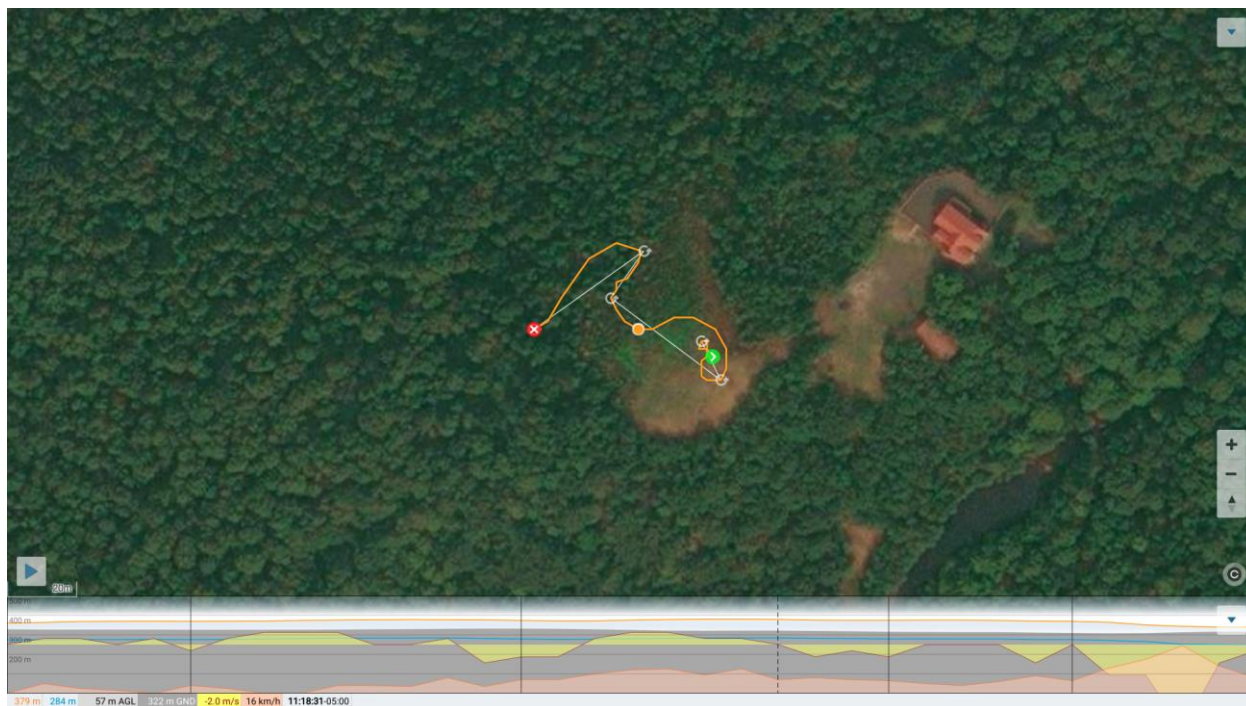
Graphic showing altitude (upper orange line), ground speed (red line) and vertical speed (green light) (XContest)

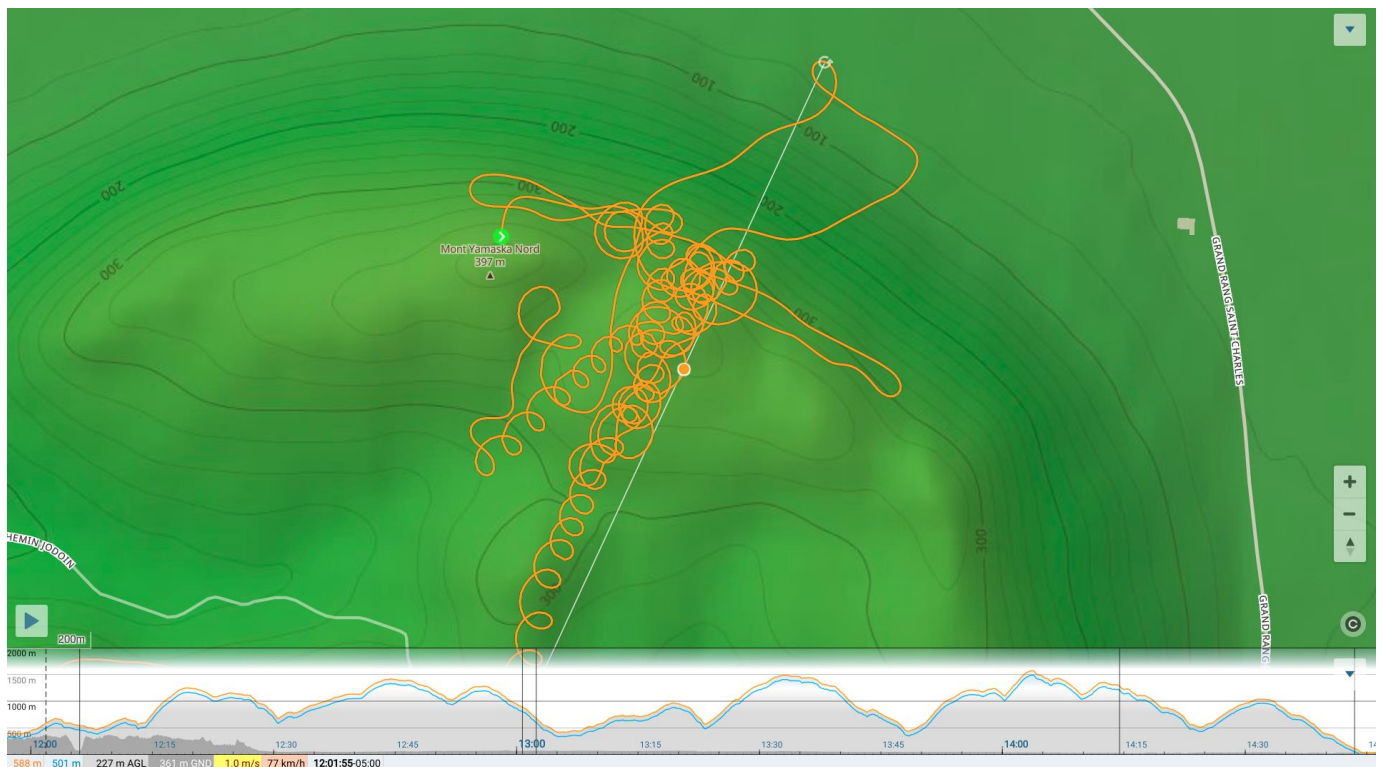
## Appendix 9: GPS track of the first hang glider that took off at 1 p.m.

Note: discussion with the pilot confirms that the hour posted by XContest from which this screenshot was taken is erroneous; it should read 13:01:55.

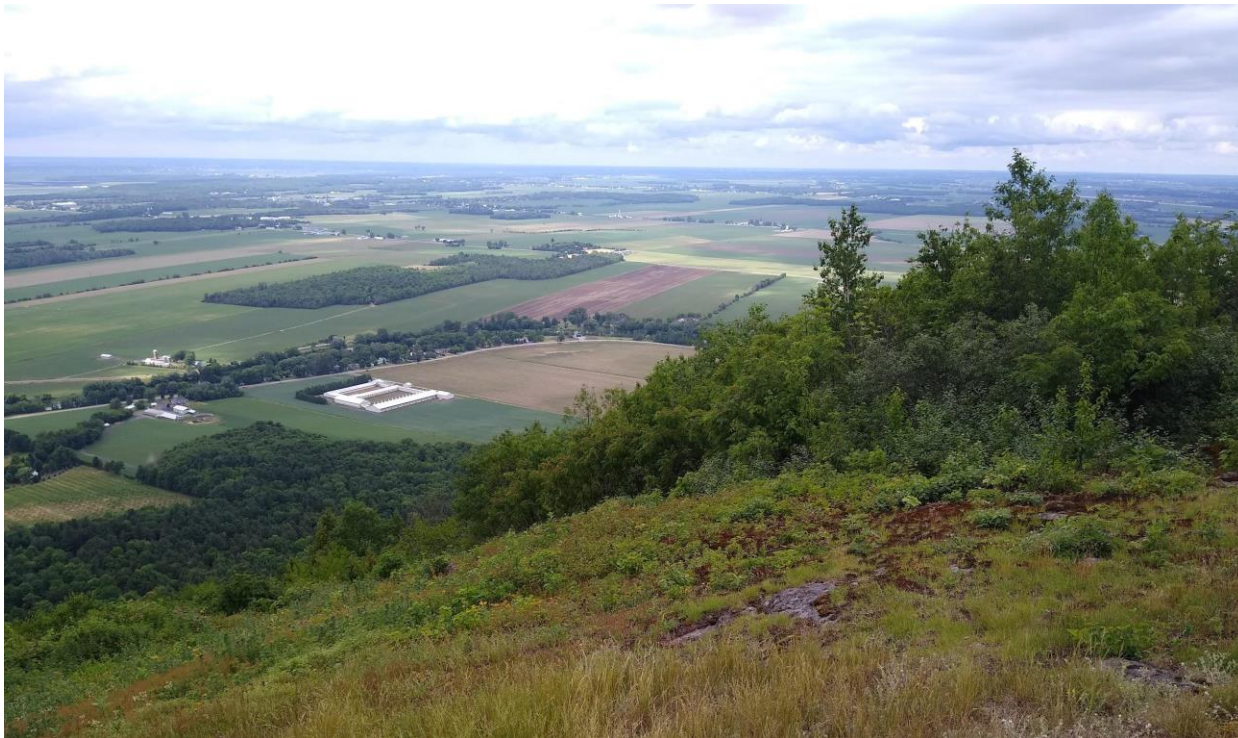
### Tree line on the North-East, right-hand side of takeoff site

- The left side of the Student's Wing suffered a large asymmetric collapse because it was hit by severe turbulence and because it was in an accelerated configuration. The severe turbulence was caused by gusts of off-axis winds (commonly referred to as crosswind) hitting the terrain and the trees bordering the take-off, mixed with thermal updrafts along the terrain;
