Hang Gliding and Paragliding Association of Canada  
Association Canadienne de Vol Libre

## FLIGHT SAFETY INVESTIGATION REPORT

PARAGLIDING ACCIDENT

MONT YAMASKA, QC

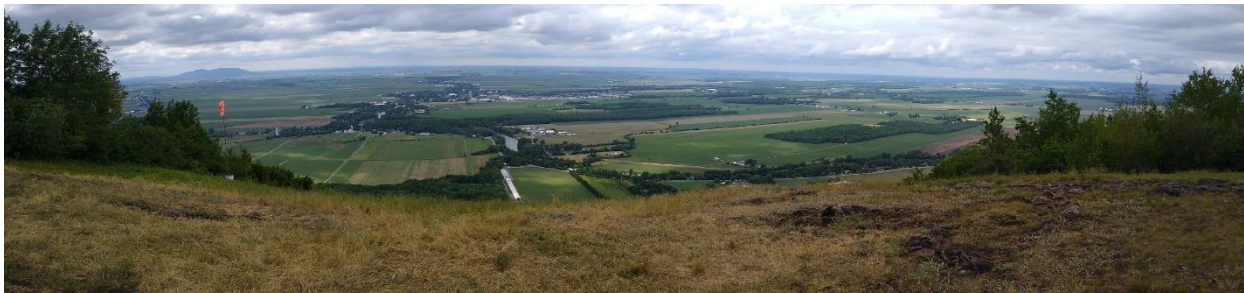
Overview of the takeoff site (panoramic format)

The terrain below PVLMY's North takeoff site is relatively clear and features groups of trees and bushes, especially on the right (east side), and several groups of rocks. The impact took place on one of those groups of rocks on the left side (west side). The Student was found face down, unconscious, without his helmet (it seems that one of the helmet straps broke under impact), his harness on top of him, the deflated Wing a bit behind on bushes (toward the North). See pictures at appendix 4.
